AVIATION INVESTIGATION REPORT
A00P0040

FAN COWL SEPARATION

CANADA 3000
AIRBUS A330-200 C-GGWA
VANCOUVER INTERNATIONAL AIRPORT,
BRITISH COLUMBIA
17 MARCH 2000

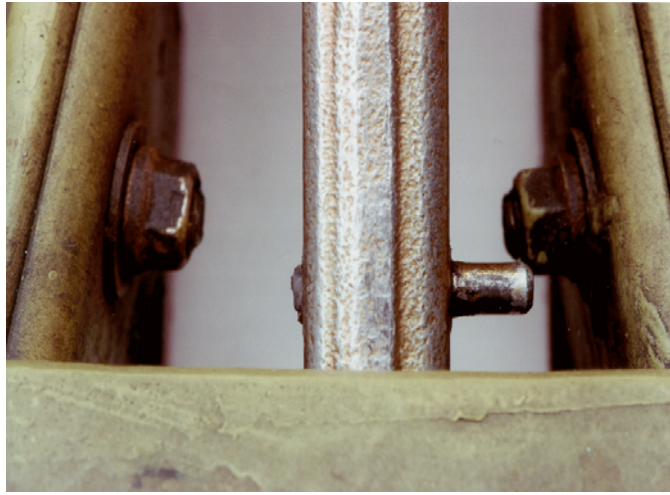
The fan cowl latch mechanism on the occurrence aircraft employs a latch fitting constructed of two sub-assemblies that are joined using four hex bolts, flat washers, and nuts. Examination of the latch mechanisms indicated that the latch fitting sub-assemblies had been assembled with the bolt threads, washers, and nuts inside the sub-assembly. Further examination revealed that interference between the trigger/safety pins and the nuts / threaded end of the bolts appeared to

be the cause of several bent and one broken trigger/safety pins (Figure 1). With the bolts installed in this fashion, the combined washer and nut thickness is almost double that of the bolt head alone.

Figure 4 - Damaged latch sub-assembly from the accident aircraft

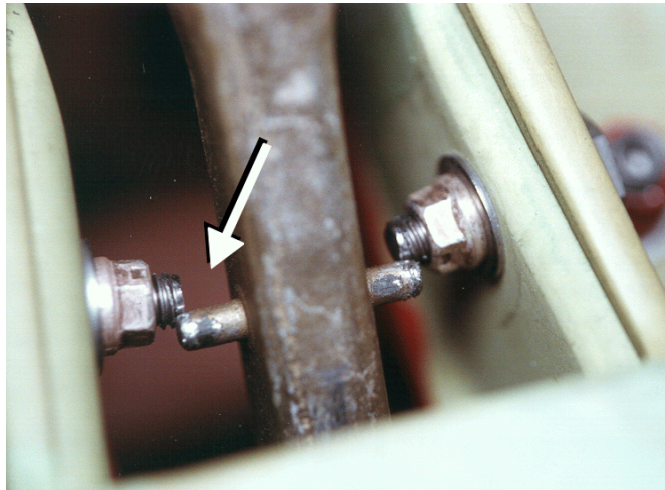
Indications of interaction between the trigger/safety pins and the fitting sub-assembly fasteners were also observed on a comparison aircraft, as shown by damage to the ends of the pins, grooves in the innermost end of the nuts, and thread imprints in the trigger/safety pins (Figure 2).

Figure 5 - Interference between trigger/safety pins and the fitting sub-assembly fasteners

1. There is no cockpit indication to notify the crew whether fan cowls are closed and secured.
2. Interaction between the trigger/safety pins and the fitting sub-assembly fasteners can damage the ends of the pins and thereby increase the risk of component failure.

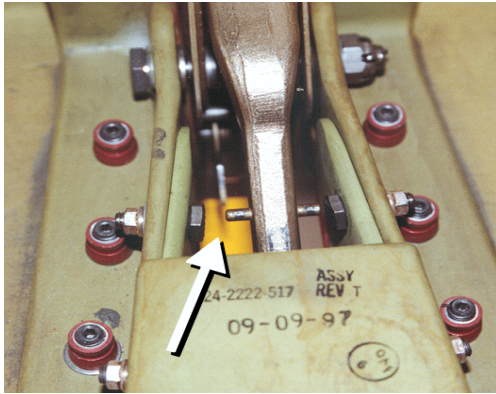
Investigators observed that the latch fitting sub-assembly bolts on the fan cowls of one engine of a similarly equipped Airbus A330 were oriented with the threaded portion facing outward (Figure 3) while those on the other engine fan cowls were oriented inward (Figure 4). Also, the bolts used in the comparison aircraft's sub-assembly were noticeably longer than those that had been used on the occurrence aircraft. The increased length exacerbated interference between the assembly bolts and the trigger/safety pins. Discussion with a representative of the manufacturer revealed that the original latch fitting sub-assembly drawing showed the fasteners installed with the threaded end of the bolts facing inward (Figure 4).

Figure 3 - Photo of bolts showing no interference

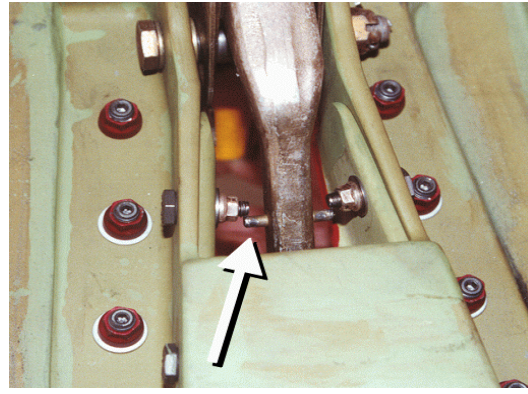
Figure 4 - Photo of bolts reversed, as in original drawings.

3. Orientation of latch fitting sub-assembly bolts with the threads inward and use of longer-than-required bolts exacerbates any interference between the assembly bolts and the trigger/safety pins.

1. issued a service bulletin (CF6-80E1-NAC-71-032) on 01 January 2001 covering the correction to the direction of latch fitting sub-assembly bolts;
2. will add a warning to the applicable maintenance manuals regarding potential damage to the latching systems from unauthorized use of tools to operate the latches; and

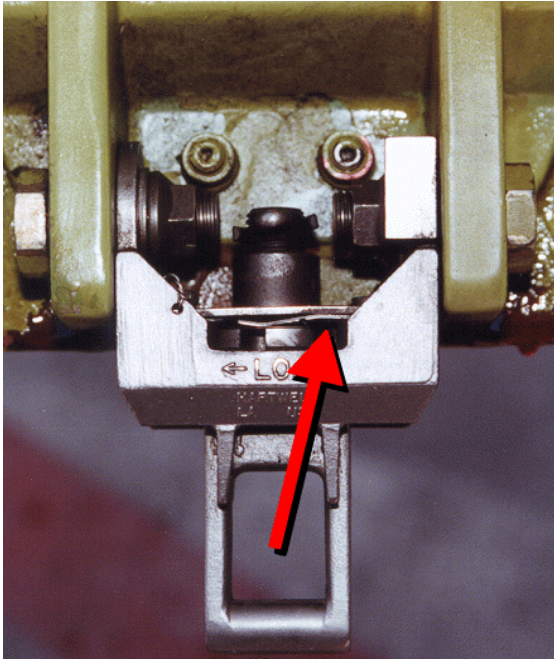
Engine fan cowl latch tension is adjusted through the use of a radially slotted adjustment star in the keeper mounting assembly. The position of the star is retained by a top and a bottom spring (adjustment star retention springs) in each assembly (Figure 5). These springs engage the corresponding top and bottom slot of the adjustment star.

Figure 8 - Normal star adjustment retention spring

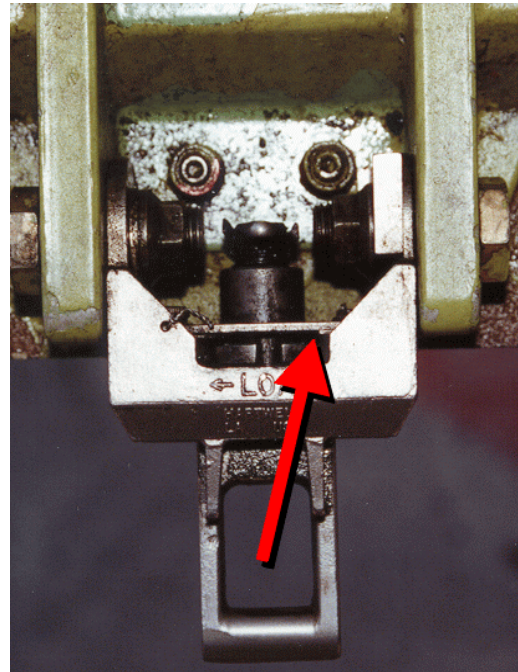
No specific damage was noted to the adjustment star retention springs of the occurrence aircraft. However, based on a brief survey of comparison aircraft that used similar components, several keeper mounting assemblies were observed, in service, with broken adjustment star retention springs. (See Figure 6 as one example.) In some of these cases, the top and the bottom springs on the same eye-bolt had failed, and there were two cases where more than one adjustment assembly was affected on the same cowl. A specific inspection procedure for the eye-bolt adjustment retention springs could not be found.

Figure 9 - Failed spring from a comparison aircraft

4. Failure of adjustment star retention springs increases the risk that the engine fan cowl latch tension will move out of adjustment.
5. By design, the height of the latches and their position at the bottom centreline of the fan cowls makes it difficult to visually detect an unlatched latch.
